TRANSACTIONS.

THE RECONSTRUCTION OF GRAND RIVER
BRIDGE.

By W. A. ROGERS, Jun. Am. Soc. C. E.

PRESENTED OCTOBER 7TH, 1896.

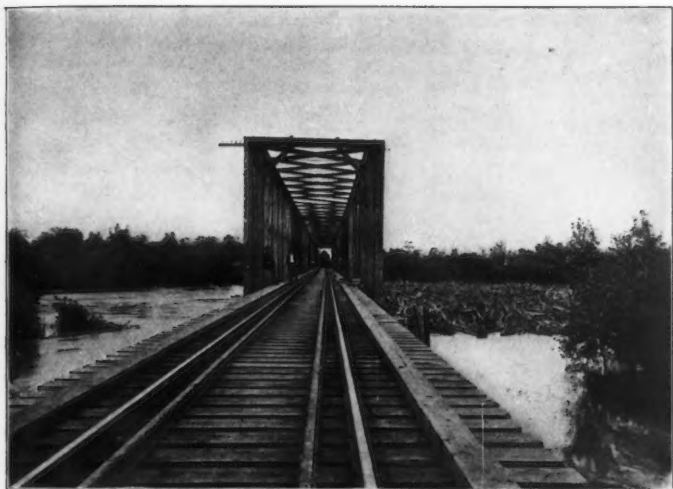
FIG. 1.

mass of this driftwood from 4 to 12 ft. in thickness, extending the full length of the spans and 700 ft. up the stream, was lodged against the piers and falsework. One of the bents of falsework was carried away and one of the piers was thrown 8 ins., and another 5 ins. out of line at the top. A view of the accumulation of drift is shown in Plate IX, Fig. 1.

Mr. Low. EMILE LOW, M. Am. Soc. C. E.—The extremely short life of the original Howe truss bridge built across the Grand River is notable. The author states that these spans were erected in 1887, and replaced by iron in 1895, being only eight years in service. Referring to Plate IX, Fig. 1, which shows an end view of the original structure, it is apparent that the bridge was not housed in. Exposure to the weather evidently hastened the decay of the timbers, the life of which would undoubtedly have been prolonged had precautionary measures of some kind been resorted to.

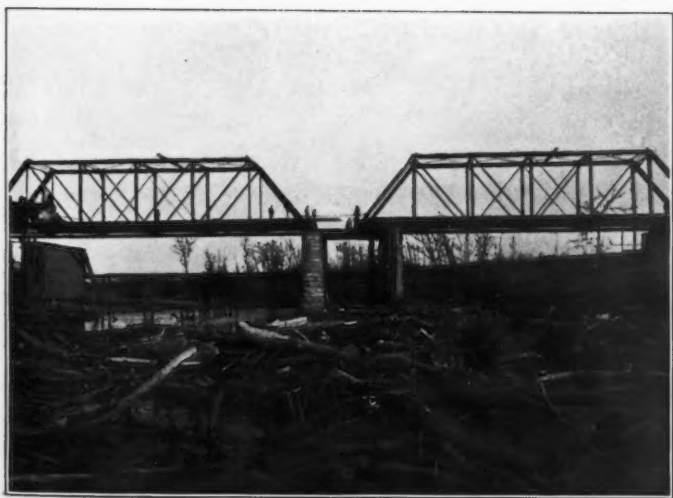
FIG. 2.

A view of the last span when half moved is shown in Plate IX, Fig. 2.
